Villanova Urban Stormwater Partnership Lessons Learned II - Porous Concrete Demonstration Site Fall 2004 Update

Executive Summary:

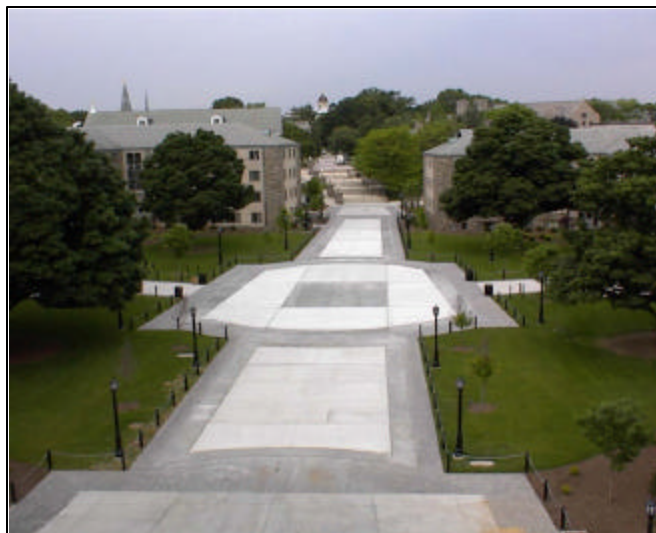
Figure 1 – VU Porous Concrete Site

A porous concrete infiltration “Best Management Practice” (BMP) was constructed during the retrofit of an existing paved area in the center of the campus of Villanova University in August 2002 (Figure 1). The contributing watershed area is approximately 50,000 ft² and is highly impervious, consisting of pedestrian walkways, rooftops and some grass areas. The rooftops and some adjacent paved areas are directly connected to three separate rock storage beds (four feet deep) that are outlined by the porous concrete surface. The rock beds are linked through piping systems to distribute the runoff between beds and allow for overflow for major storm events. The porous concrete surface is edged using decorative pavers with the porous concrete outlining the site and standard concrete in the center of the site. Installation involved demolishing the original site, extensive regrading, and construction of the infiltration BMP (Traver et al., 2004). A strength additive was used. The site was designed to capture and infiltrate the first two inches of runoff, thereby reducing downstream stormwater volumes, stream bank erosion, and non-point source pollution. The project joins the Villanova University “Best Management Practice Demonstration Park” as both a research and demonstration site (Traver 2002). Funding for the project was through the Pennsylvania Non-Point Source Pollution Section 319 Program, and the site has been designated as an EPA National Monitoring site. Further information on this and other projects can be found through the Villanova Urban Stormwater Partnership website (www.villanova.edu/VUSP).

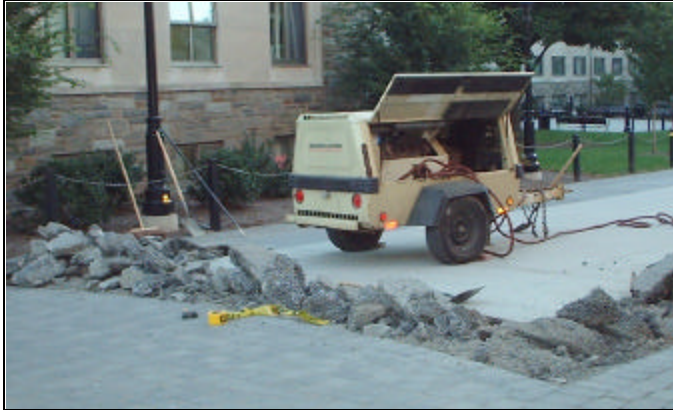
Figure 2 –Demolished Concrete on Upper Bed

In October of 2004, during Villanova University's Fall Break, construction was performed at the site to replace sections of the porous concrete that had failed or were not functioning properly, approximately 40% of the reconstructed surface (Figure 2). It was observed that the areas of porous concrete that had failed were from the later parts of each individual pour, and that the first portion of each pour was in acceptable to good condition. It was also observed during the original reconstruction that the end of each pour was less malleable, and extremely hard to work. As only the top layer of the porous concrete had failed, it is speculated that impermeable layers were formed at the end of the pours allowing freeze thaw to occur.

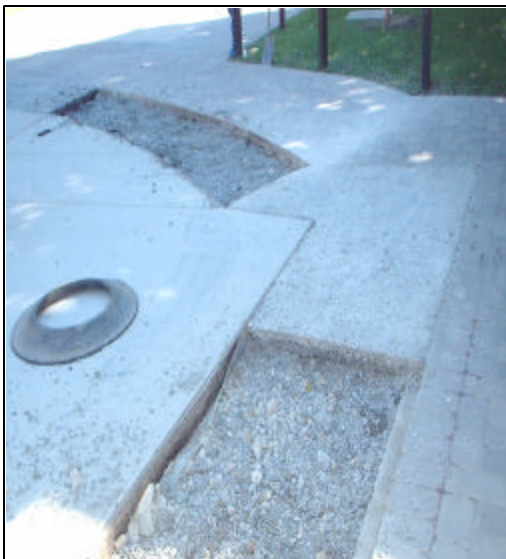
Figure 3 –Sections of removed PC

Demolition began on site on October 12, 2004 with the uppermost bed. A total of twelve sections of porous concrete were removed from the site (Figure 3). The sections to be replaced had been marked prior to demolition by Villanova's Facilities Management Office. Each section was saw cut and subsequently jack hammered to break up the porous concrete. The large chunks that were removed appeared to be in good condition other than at the surface. The large pieces were removed by hand and some of the gravel was shoveled out. This process did produce some fines and gravel, but the magnitude of which was not substantial enough to clog the pores and prevent water from infiltrating into the bed. The demolition also ripped up the joints between the porous concrete and the standard concrete, which were to be

replaced during pouring. Demolition was completed at the end of the first day.

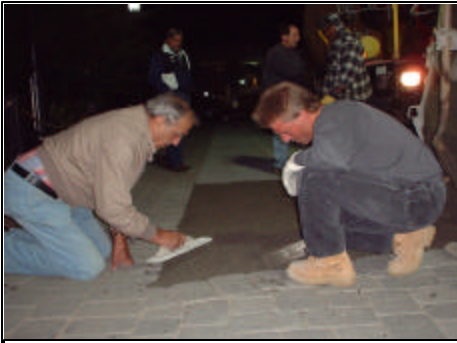
Figure 4 – Hand Trowling PC

Pouring began at 6AM on October 13th in the upper bed. The expansion joints had been replaced, marking each separate porous concrete pad. Initially, the pour from the first mixer appeared to be too gravelly and dry. The placement was halted, and workers spread out what had already been poured. The remaining concrete was mixed in the drum for an additional period of time and the pour was resumed. This pour was a much better consistency, and they began again and worked along in small sections. The mixture was poured 1½” above the surrounding surface, as opposed to ½” higher as in the reconstruction in ‘03, so that a

roller with higher compaction could be used. The higher compaction also allowed the workers to get the porous concrete flush to the standard concrete already in place, without the elevation difference that was noted during the previous construction (Figure 4). A hand trowel was used after the porous concrete was raked into place to ensure the pour was even and filled all gaps. The concrete sections were then quickly compacted with the roller which was hosed down each time before passing over the concrete to prevent the concrete from sticking to the roller.

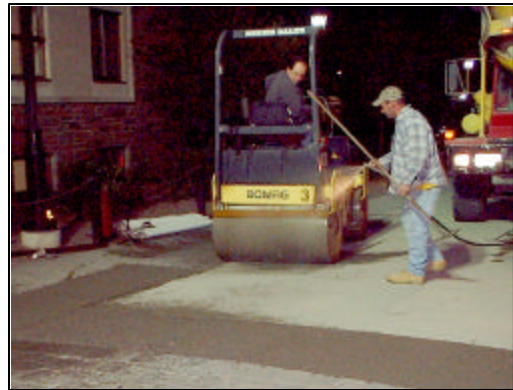
Figure 5 – Rolling Porous Concrete

On the first section poured, a hand tamper was used preceding the roller, presumably to compact portions of the porous concrete at the edge in order to ensure that it was flush with the standard concrete. However, the roller itself seemed to be accomplishing this, so this was not continued. Also, on another section the contractor attempted to have water continuously flowing from the roller, rather than having it sprayed on the roller by hand, but this produced a smooth (non-porous) surface, due to the porous concrete becoming too hydrated and created an impervious section (Figure 5).

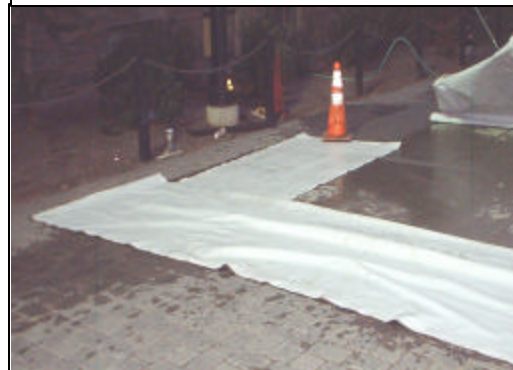
Figure 6 – Wet Burlap Covering

After compaction, each section poured was covered with wet burlap strips (Figure 6). This material is heavier than the plastic that had been used in the previous construction so it remained in place over the concrete throughout the recommended 48 hour period and provided for better hydration.

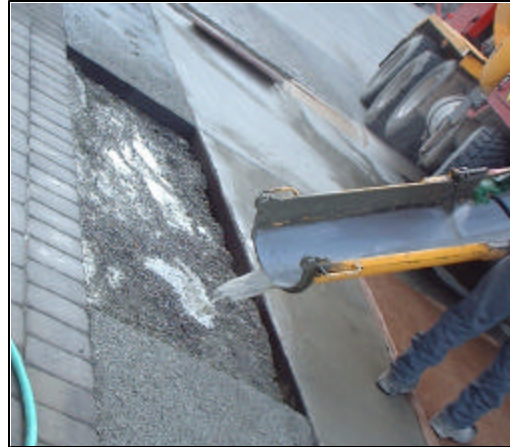
Figure 7 – Non Porous Area at End of Truck

The second mixer on site had a similar consistency to the first mixer, but at the end of the second mixer the remaining material that flowed down the chute was extremely wet and gravelly, leaving water ponding on the surface of the pad (Figure 7). This section was removed and repaved when construction resumed on October 16th at 6AM following a two day delay due to adverse weather conditions. Paving was completed on the second day of pouring. It was observed that the “florida” mix was much easier to pour than the previous mixture, and no problems with stiffening occurred during the pours.

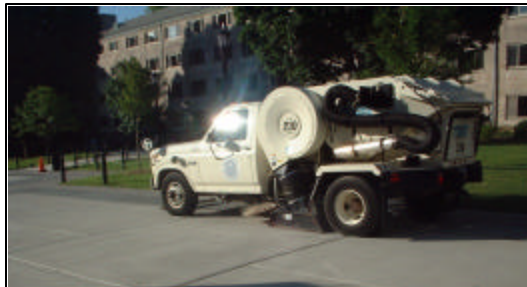
Figure 8 – VU Vacuum Street Cleaner

It is generally recommended that porous concrete surfaces be vacuum swept at least twice a year to keep the concrete free of pore clogging debris. Street sweeping was performed on the Villanova site in August and December 2004 (Figure 8). This cleaning was very successful in removing the particles that could potentially clog the porous concrete. The porous concrete was visibly cleaner after the street cleaner passed over it and the removed debris could be seen in the truck.
