Villanova Urban Stormwater Partnership

Lessons Learned - Porous Concrete Demonstration Site

By Robert Traver, Andrea Welker, Clay Emerson, Michael Kwiatkowski, Tyler Ladd, and Leo Kob

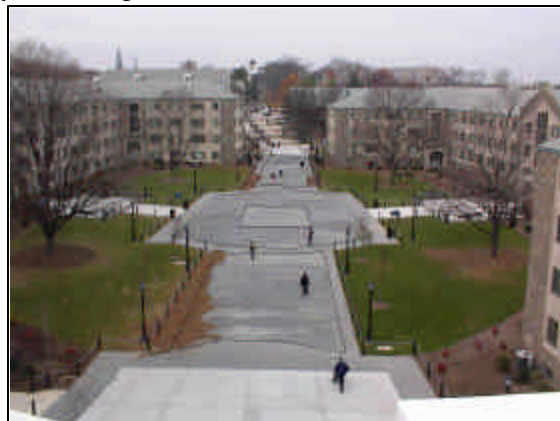
Figure 1 – BMP – Initial Surface

The original design consisted of three large porous surfaces bordered with pavers as shown in Figure 1. The original plan was for the material to be batched offsite, poured and spread, and then leveled using a traveling vibratory screed, hand compacted, and finally covered. An admixture to improve bonding and thus strength of the concrete was to be added to the drum at the site prior to pouring. Before construction a small test pad (130 ft²) was poured from a visual inspection appeared to be satisfactory in porosity and strength. The chief concern from the test pad experience was the cosmetic appearance of the material. Two tamping methods (hand, vibratory) were tried.

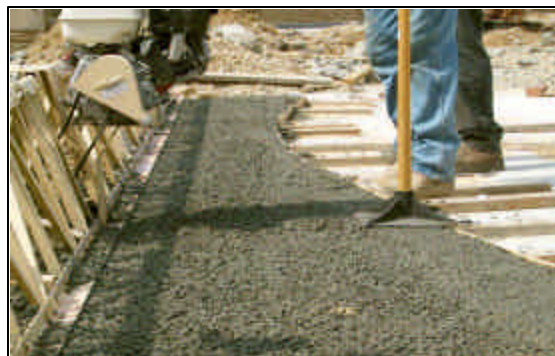
Figure 2 - Initial Pour and Hand Tamping

The first truckload of concrete lacked the desired consistency. The concrete resembled wet, loose gravel and was discarded. It was assumed that too much water had been added which prevented the concrete from curing properly. The second truckload of concrete arrived shortly thereafter and appeared to have a better consistency. It was poured and then spread by shovels and rakes. The vibratory screed was not useful because of the poor workability of the material (stiffness). Once spread, a vibratory tamper was used to smooth and lightly compact the concrete. Originally a hand tamper was used. Unfortunately, hand tamping proved to be time consuming and the laborers could not keep up with the pour. Later, a vibrating push tamper was modified with a larger bottom plate and used to finish the concrete behind the screed. This technique was successful because the compaction was distributed over a larger area thereby improving the final surface appearance. It was observed that there was a small window of opportunity in which the concrete maintained its workability.

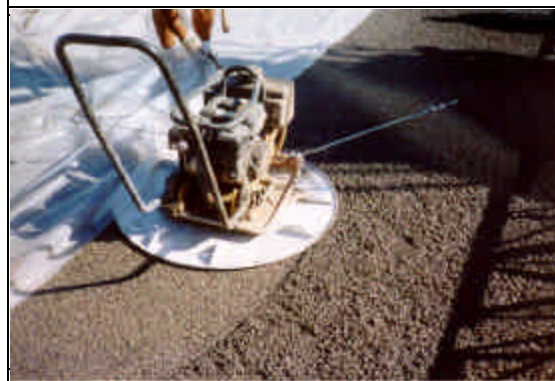
Figure 3 - Vibratory Tamping

The traveling vibratory screed used to level and compact the concrete proved to be cumbersome and ineffective. The screed was used because the pours were 15-25 feet wide. Simply moving the concrete material side to side was extremely difficult. The setup speed was extremely fast compared to conventional concrete, and often the end of a full drum's pour was extremely difficult to work, leading to irregularities in the surface appearance and ruts.

- Rolling is the preferred compaction method. Vibratory tampers create ridges that are difficult to detect visually until after concrete has hydrated.

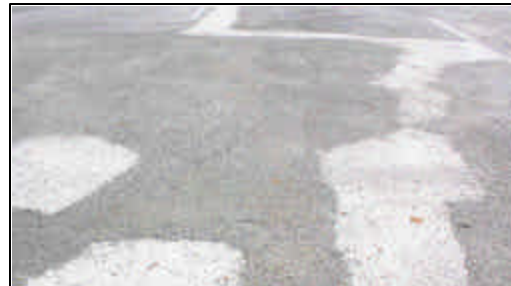
Figure 4 – Patched Surface

Once the entire site was constructed it was clear that the final finish of the porous concrete would not be acceptable. In many locations the surface of the concrete was rutted while other areas did not set up at all and resembled loose gravel. It was theorized there may have been cement remaining in the concrete that had not yet hydrated. The contractor brushed and wet the concrete to in an attempt to promote hydration. Many of the areas of loose gravel were removed and patched with another batch of porous concrete. This created a tremendous variation in color and texture of the concrete as shown in Figure 4. Due to the start of classes, there was no time left for further repairs.

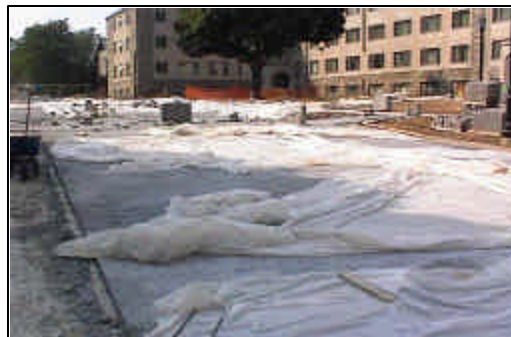
Figure 5 – Ineffective Covering

was covered with plastic sheets; however, the covers were not secured adequately and blew off the concrete soon after being laid down. The large size of the pour made covering extremely difficult. Therefore the concrete that was poured was not allowed to properly hydrate, which contributed to the observed surface failure.

Covering of the concrete to promote proper hydration was ineffective. After the concrete had been poured and compacted, it was sprayed with the additive and water mixture as per the specification and then covered with large sheets of plastic. The plastic was not put down until 15 or 20 minutes (or later) after compaction. During the heat of the day, this delay in covering the fresh material may have played a significant role in the failure of the surface. While this was apparently "normal" construction practice for regular concrete, the large void spaces in porous concrete may accelerate the drying process. Once placed, the plastic sheets were held down at the edges by rocks, cinder blocks, buckets, and pieces of wood. Often during the 24 hours after pouring, the plastic sheets came loose, causing the concrete to dry too quickly.

roller prior to and during the compaction process helped keep the concrete from sticking to its face. Immediately after rolling, the concrete was covered with plastic sheets and properly secured. This process was maintained throughout the pour duration. The plastic was not removed until at least 48 hours later.

- Concrete must be tightly covered for a minimum 48 hours after placement.
- Existing concrete material specifications and testing standards are inadequate for both batch plants not experienced with porous concrete and when “proprietary” binding admixtures are used. Our experience indicates the only people capable of insuring proper batching and placement are the bonding admixture manufacturers or contractors with a proven porous concrete installation track record.

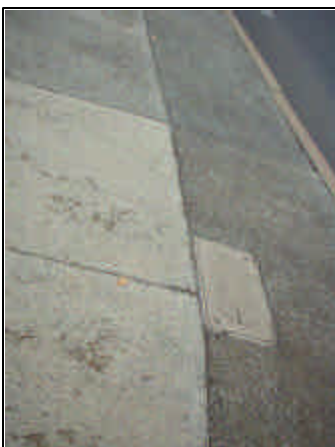
Figure 6 –Visitor Center Sidewalk

Three existing sites were visited by representatives from Villanova University and the contractor prior to the redesign. The first visit to the Centre County Visitor Center adjacent to Pennsylvania State University was encouraging. Porous concrete (no admixture) had been used to construct a sidewalk, which had been rolled during construction. The surface was smooth and durable, but the color variation of each pour was evident. Two sites were visited near Raleigh North Carolina. The first was an older site where the driveways and a cul-de-sac were all porous concrete. Again, the surface was durable. The second site was a very large parking area at the University of North Carolina that had included an admixture. The surface appeared durable, but the cosmetic appearance was inconsistent. While this was acceptable for a parking area, it was not acceptable for a central pedestrian mall that was to be a showcase on Villanova’s campus.

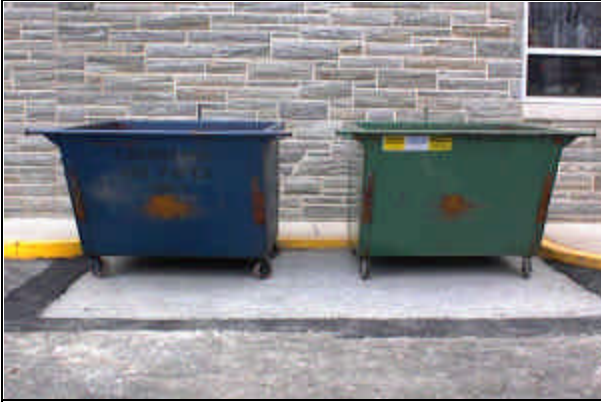
Figure 8 - Test Pad

Based on the site visits, it was decided to construct several concrete test pads to give the contractor more experience and to check durability and surfacing techniques. The first 200 ft² (built in the fall of 2002) was acceptable for durability, but the surface color varied excessively (partially because the contractor tried several compaction techniques during the pour). To provide a “larger” test, four 100 ft² porous concrete dumpster pads were installed at various locations on campus prior to the start of reconstruction as shown in Figure 8. This was done to compare two mix designs as well as compaction methods. As will be discussed below, several new quality control measures were imposed on the batch plant. Two of the pads were constructed using a bonding agent and two without that admixture. A vibrating plate tamper was used to compact two of the test pads and a 50 gallon, 48” wide, plastic drum roller filled with water was used on the other two. Following construction of the test pads, each was inspected and core samples

taken for compaction strength testing. Each test pad's porosity was verified by pouring water on the pad and observing how quickly it infiltrated. From the test pad trials it was determined that the mix containing a binding agent and compacted with the roller provided the best results. The roller was filled with water to exert a 10 psi load. The mix containing bonding additive was judged to be more uniform in color and produced higher strength concrete. An important advantage for the admixture was that the manufacturer had

- Regarding placement practices:
 - Multiple test pours are strongly recommended using the same foreman and crew as will be used for actual construction. Test pads should be at least 200 ft² to detect surface unevenness.

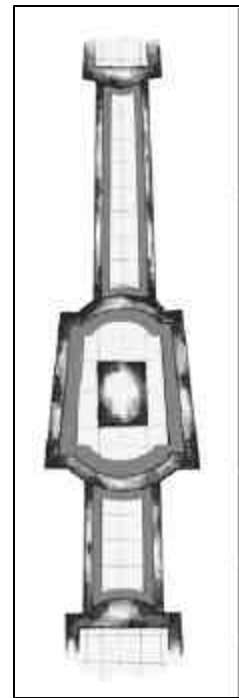
Figure 9 - Redesigned Site

From initial data and observations of the site it was determined that the original design had more than enough porous concrete surface, and this area could be decreased without effecting the site's performance. Therefore a new layout was designed which included narrow strips of porous concrete around the perimeter of each bed with conventional concrete replacing the porous concrete in the middle. Pavers remained along the perimeter. The impervious concrete was crowned along the center strips to promote drainage toward the porous strips on the perimeter. These narrow strips allowed the concrete to be compacted using the 50 gallon roller instead of the vibratory screed. The roller covered the entire width of the surface, and limited the amount of distance the concrete had to be spread.

- Design the porous surface as a series of narrow strips to promote surface uniformity. Narrowing the width of the pour reduces movement during placement of the material, allows for rolling the complete width with each pass, provides the opportunity for immediate coverage to promote even hydration, and minimizes visual ridges resulting from uneven rolling.

- Use a series of perimeter strips, and design the non-porous surface to drain as sheet flow into the porous concrete surface. The incredible infiltration capacity of porous concrete makes it unnecessary for the whole area to be porous. It must be cautioned that concentration of runoff can overload the capacity of the porous concrete surface. We found that runoff from the regular concrete follows the expansion joints and can, during severe weather, concentrate and overload the porous concrete. A better design to capture more runoff from intense rainfall periods would be to have the runoff cross multiple porous strips, and to anticipate the channeling effect of the expansion joints. This would also provide redundancy to protect against areas that clog over time.

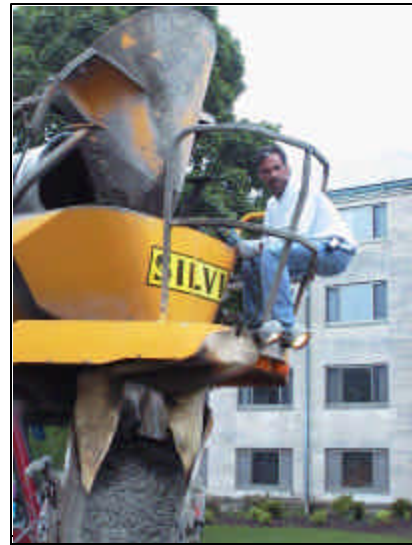
Figure 10 - Concrete Truck and Foreman

Each truckload contained 6-7 yd³ of material. Ten gallons of water per yard of concrete were typically used, but this varied from nine to eleven depending on weather conditions. The foreman remained at the top of the truck so that he could see into the drum and examine the mix's consistency (Figure 10). Batching typically lasted between five and ten minutes. After adding the water, the admixture was slowly introduced. The specifications call for 3.3 gallons of admixture per yard of concrete. Once this was added, the concrete was thoroughly mixed again for approximately five minutes before reversing the drum so it could be released into the chute. The batches were often "hand-sampled" to visually determine slump. It was at this point that the foreman would decide if the consistency was correct or if it needed more water or mixing. He would periodically "feel" the hydration rate (heat) inside the drum by laying the palm of his hand on the rotating drum's exterior. If it was satisfactory, the material was poured. If not, steps were taken to remedy the situation until the desired consistency was achieved. The entire process of mixing took an average of 20 minutes from the introduction of water into the drum to release for pouring. This relatively quick mixing process may have played a key role in maintaining the concrete's workability during the pour. While the workability was greatly improved, it did prove difficult at the end of each load as the concrete began to hydrate. This is why a drum's maximum 9 yd³ capacity was not utilized.

- Field introduction of water and bonding agent should only be performed by experienced porous concrete personnel. Due to the product’s very low slump, its workability must be determined visually before mix is “run down the chute.” Adjustments in water quantity, number of drum rotations, and admixture introduction must be performed quickly to insure workability. Hydration heat monitoring in drum is important.

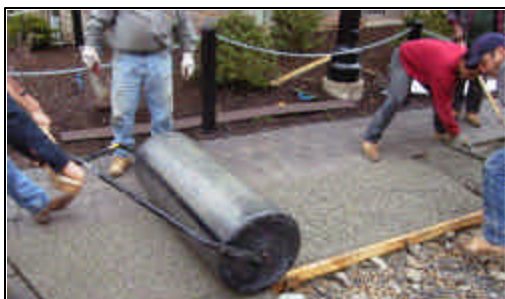
Figure 11 – Rolling

Rakes were used to move the concrete horizontally no more than 24 in. Excessive movement within the pour resulted in a blotchy surface. Troweling or movement with shovels was not permitted, as they left spots of "glazed" surface. The rolling compaction technique proved to be far superior to the vibratory screed and plate tamper used in the initial construction. The narrow pour widths allowed the crew to quickly prepare the concrete for rolling and cover. It was found that wetting the 50 gallon

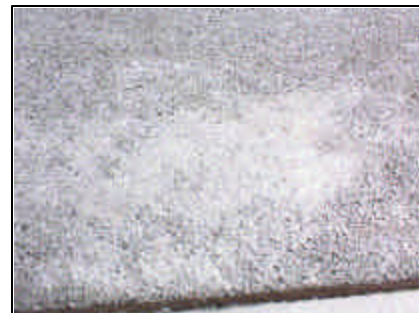
Figure 12 - Non-Porous Area

Some minor inconsistencies remain. In a few areas the concrete appears to be almost glazed over with excess cement. While these areas are probably the most durable and strong, they have little or no porosity as the voids have been clogged. This could be a result of the mix being too wet. Observations made during the construction seem to support this theory.

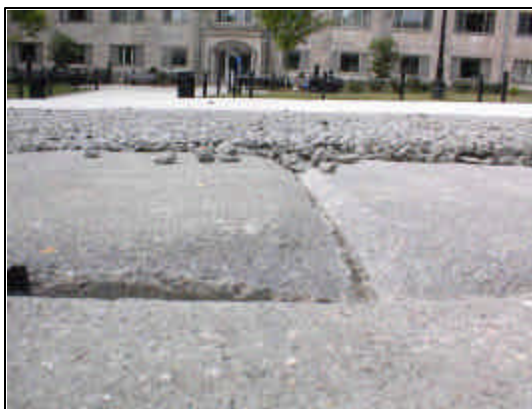
Figure 13 - Elevation Differences

In some areas where the porous concrete meets either conventional concrete or the decorative pavers there are slight differences in elevation. This difference is likely a result of excess material prior to compaction. Before compacting the concrete, the material was intentionally elevated approximately ½” such that the material, when sufficiently compacted, ideally would reside at the same level as its border. With too much excess material, the drum roller would compact the material, but still leave the material above its intended finished elevation. This protruding edge could create a vulnerable spot where the concrete could be chipped.

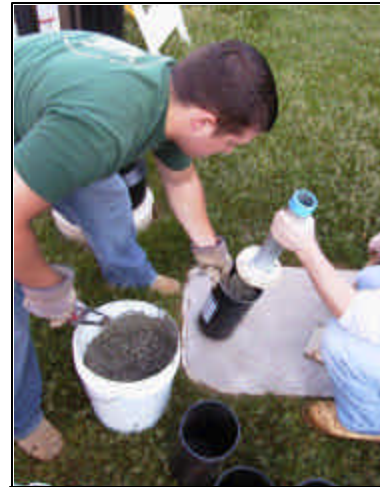
Figure 14 - Test Cylinder Preparation

On May 29, 2003, four sample cylinders were molded to conduct compressive strength tests. There is no ASTM standard procedure for molding porous concrete cylinders so a method developed by Eco-Creto of Texas, Inc. was used. The method involved filling a standard six inch diameter cylinder with concrete in three lifts. Each lift was compacted using a six inch diameter tamp struck with six firm blows. The cylinders were then covered and allowed to cure. Two of the cylinders were broken on July 3, 2003. The results of the two breaks were 3,460 psi and 3,412 psi. However the samples taken from that truck appeared to be too wet and therefore the concrete did not appear to have sufficient void space. This may have accounted for the high compressive strengths. The remaining two cylinders are being kept for future testing.

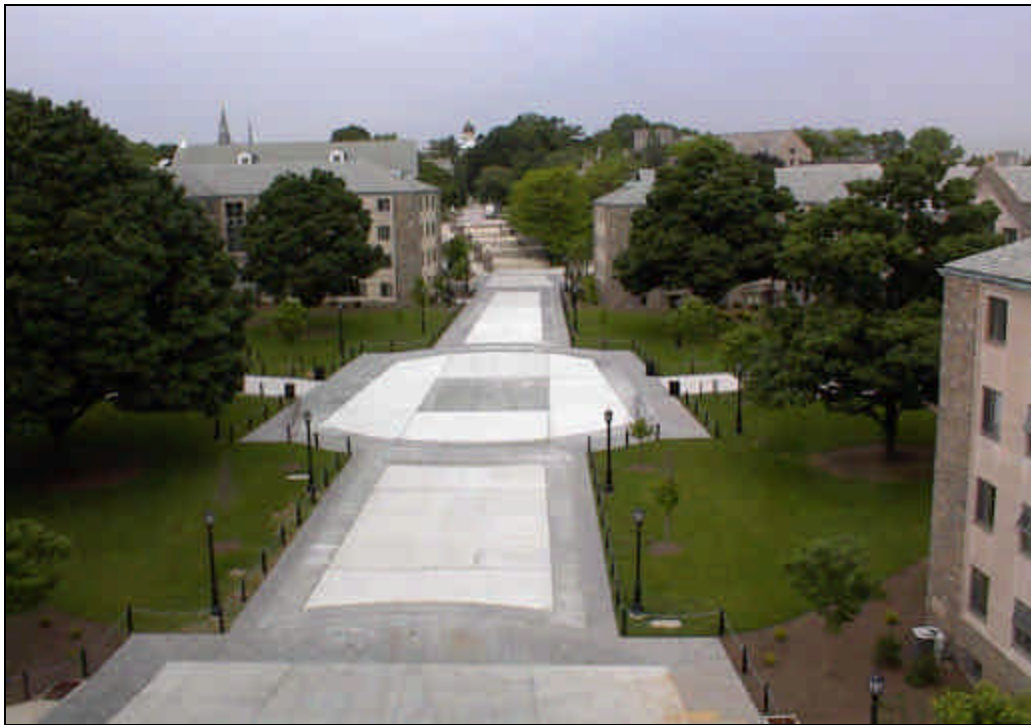
Figure 15 – Reconstructed Surface

In conclusion, the reconstruction of the porous surface was successful. The surface is porous, durable, smooth and attractive.
